Subject: Traffic Safety Report of January 2, 2014

TRAFFIC SAFETY COMMITTEE REPORT

Thursday, January 2, 2014

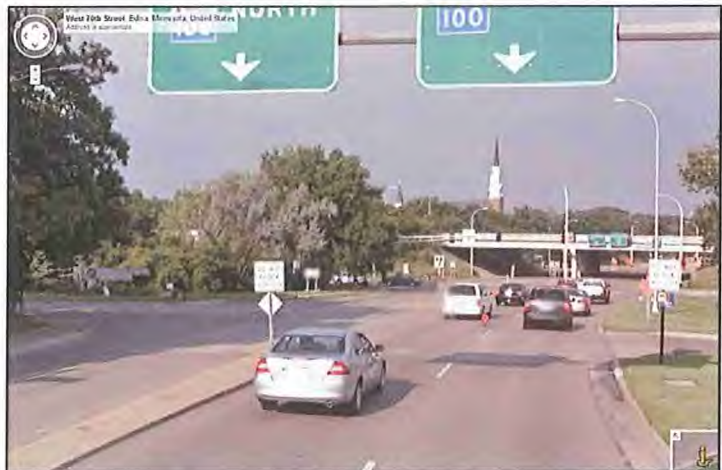
Currently there are two do not block intersection signs located on eastbound 70th Street, located at the intersection. 70th

Street is a divided 4 lane roadway. The south leg of the intersection is an entrance for a parking lot. The north leg of the intersection, Rabun Drive, is the only entrance on the south side of Brookview Heights neighborhood.

Picture: Rabun Dr. and 70th St. taken from Google maps

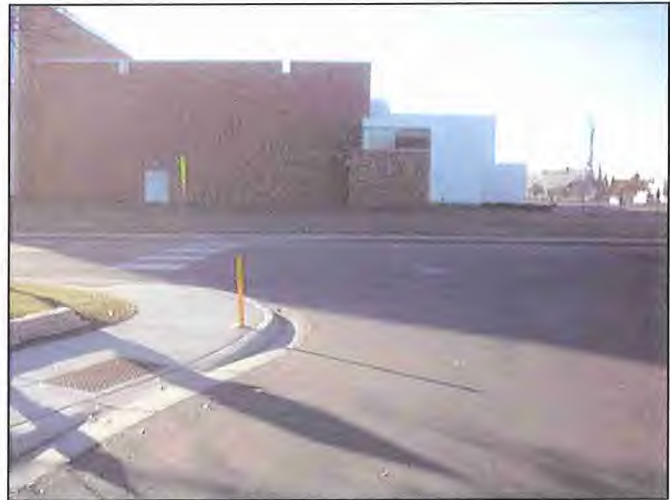
Counts of pedestrians were taken at the intersection. A maximum total of 19 pedestrians were recorded crossing South View Lane within a two-hour period. The ADT for this intersection is 3701 vehicles with the peak hour being 7:00 am. A gap study was performed during the peak hour, resulting in 8.8 gaps.

Photo: South View Ln and Dalrymple Rd from the north

After discussion the staff recommends denying the request for additional signage, since existing signage and markings are already adequate based on the city policy.

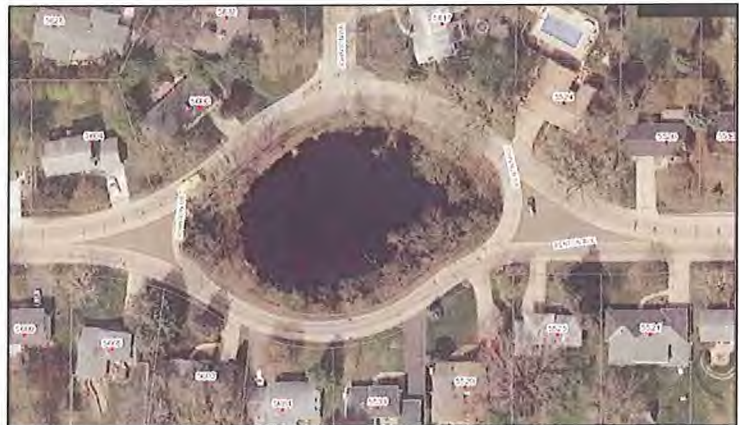
Currently Benton Avenue has a one-way traffic circle with three exists. There are parking bays on the west and east sides of the traffic circle as shown on the map.

Map: Benton Ave. parking bay

A traffic study was performed, with a camera set up to the west of the parking bay. In a 24 hour period; 2839 vehicles passed the parking bay, 5 vehicles parked in this area, 1 vehicle performed a U-Turn.

After discussion the staff recommends denying the request for a No U-Turn sign.

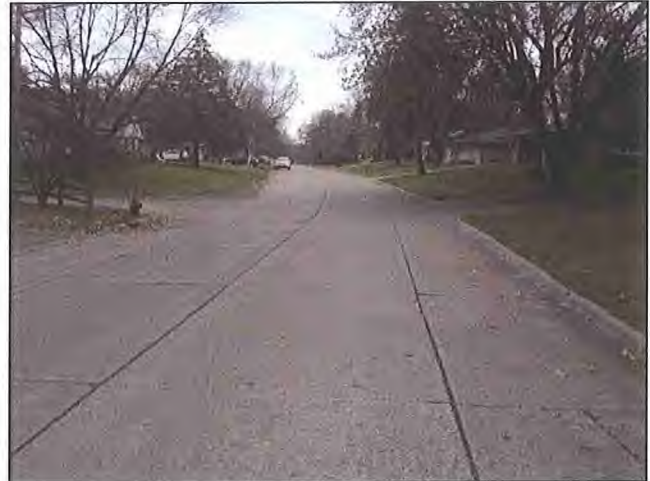
During the December 4, 2013 meeting, the traffic safety committee recommended looking further into the crash from 2013 to determine if it was an unavoidable crash. In an overview of the crash, the driver of the vehicle struck crossing St. Johns slowed down, but did not see the vehicle traveling down St. Johns. It was noted the Yield sign has a tree near it with a branch hanging down which may or may not be blocking the Yield sign.

Photo: St. Johns Ave. looking south

After discussion the staff recommends denying the request for replacing the Yield signs with Stop signs. Staff will check to make sure the Yield signs are clear of obstruction.

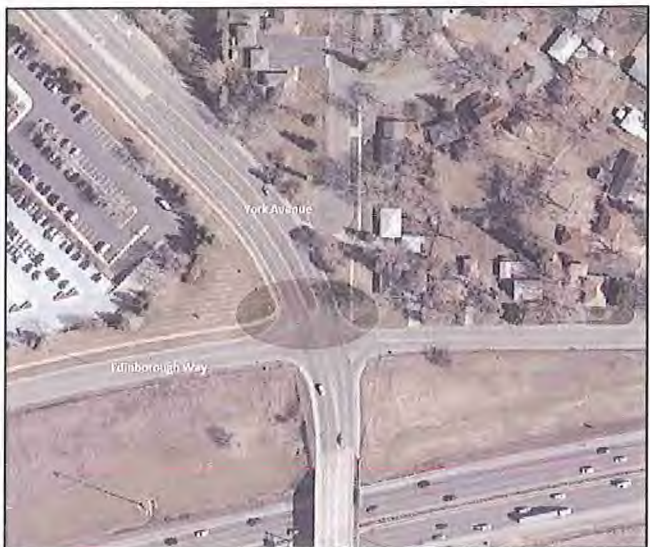
Currently there exist crosswalks on the north and west legs of the intersection, but without any signage. There is a median, crossing island, crossing York Avenue which can be used as a safe haven for pedestrians. There are stop signs on Edinborough Way. The speed limit on York Avenue is 35 mph.

Map: York Ave. and Edinborough Way

After discussion the staff recommends further study and communicating with Hennepin County before making a recommendation.

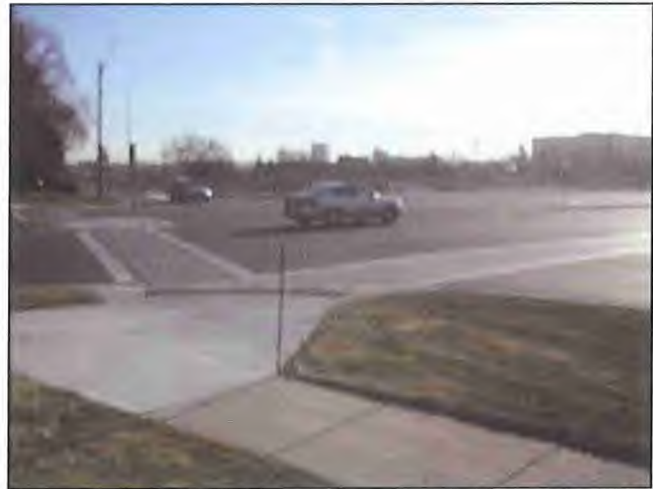
The ADT for this intersection was found to be 11,662, with the peak hour occurring at 4:45 pm. A gap study was performed during this peak hour. The MNDOT Traffic Signal Timing and Coordination Manual states on divided roadways; *a divided road is one with a median island over 6 feet wide and includes a pedestrian pushbutton in the median. If a pushbutton is not in the median, the recommended practice, pedestrian clearance interval must cross them completely from near side curb to far side curb.* This means for the gap study the crossing island should not be considered a “safe haven”. The gap study resulted in 0.8 gaps on average for a 5 minute

Picture: York Ave and Edinborough Way from NW

period. If the crossing island were to be considered a “safe haven”, the gaps for northbound traffic were 10.5 and for southbound traffic were 14.3 gaps on average for a 5 minute period. The Local Traffic Control list recommends installation of an overhead mounted flasher for less than 3 gaps, and pavement markings and signage for above 5 gaps.

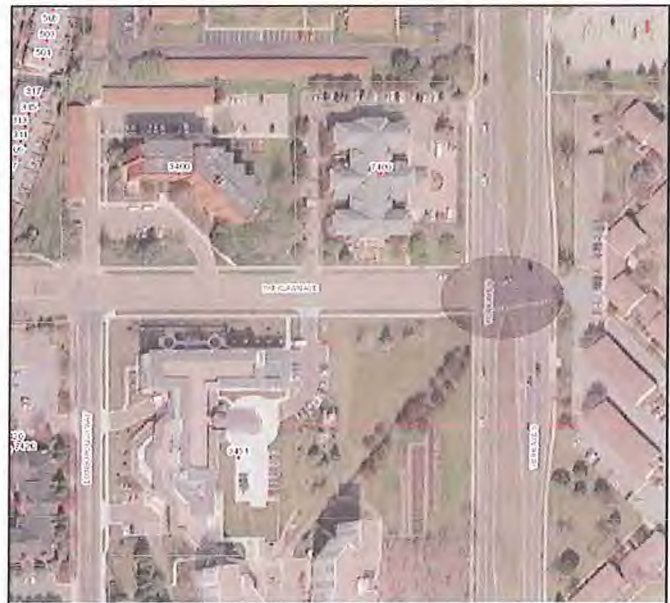
Currently there are painted crosswalks on the south and west legs of the intersection. There are crosswalk warning signs located on York Avenue north, south, and immediately at the crosswalk. No signage is located on Parklawn Avenue. York Avenue is 6 lanes wide, including 2 turn lanes at the crosswalk, with a distance of 126 feet from curb to curb. Parklawn is 4 lanes wide, with a distance of 65 feet from curb to curb. There have been 9 accidents at this intersection since 2009.

Map: York Ave. and Parklawn Ave.

After discussion the staff recommends further study and communicating with Hennepin County before making a recommendation.

Section C2. Transportation planner Nolan said Hennepin County has offered to install a rapid flashing beacon and an enhanced crosswalk in 2014 and he is checking to see if they would consider straightening out the crosswalk and adding a pedestrian refuge.

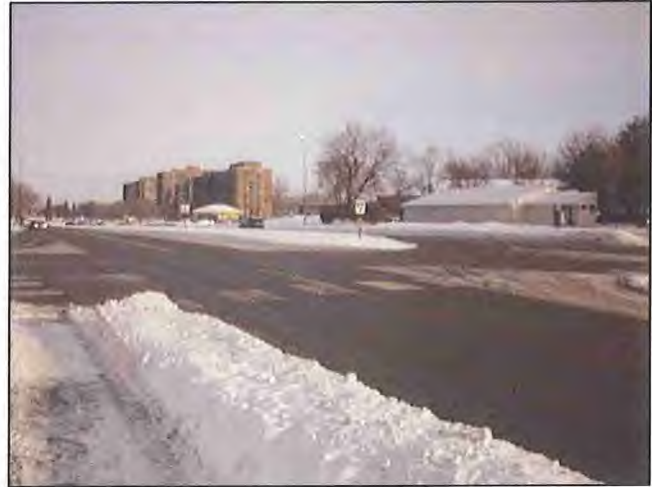
A traffic gap count was taken during the peak hour, 5 pm. The average gaps per 5 minute period on York Avenue were 0. The average gaps per 5 minute period going across Parklawn Avenue were 1.7. Both of these were below 3 gaps, according to the Local Traffic Control list it's recommended to install an overhead mounted flasher.

Picture: York Ave. and Parklawn Ave. from the south

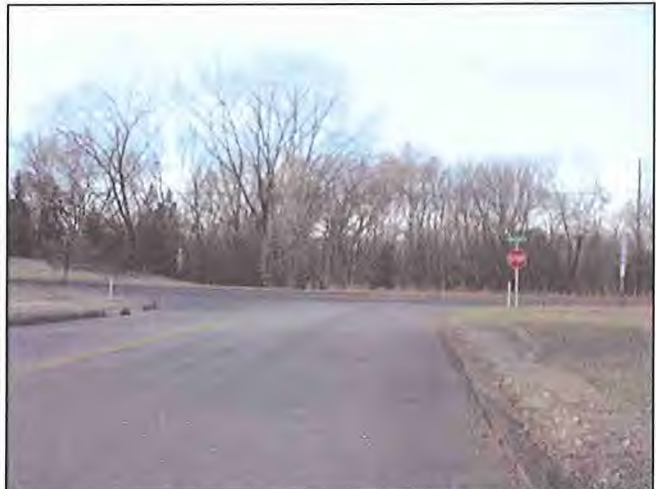
Currently there exist a stop sign on Valley Lane westbound. There is a left turn lane for southbound Valley View Road. There are 8 recorded crashes at this intersection since 2008, including several failures to yield the right-of-way and a vehicle making a left turn.

Picture: Valley View Rd. and Valley Ln. facing west

After discussion the staff recommends including study of this intersection along with traffic analysis of Tracy / TH 62 associated with future Tracy Avenue reconstruction before making a recommendation.

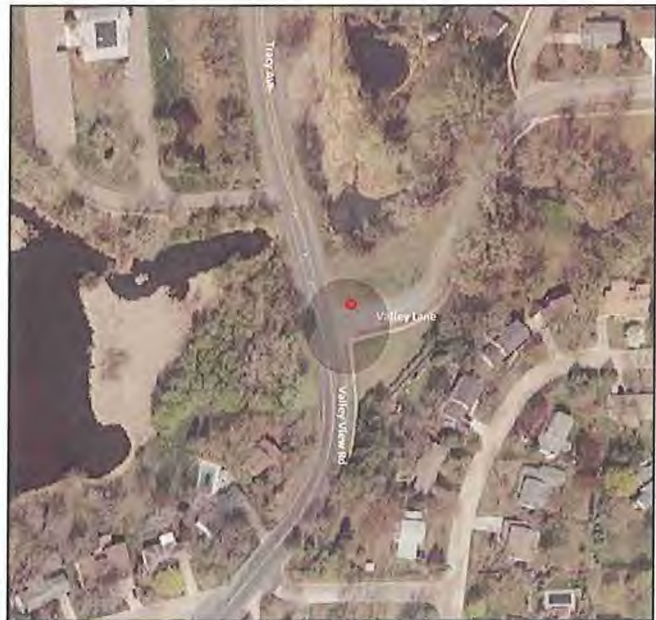
The volume of traffic entering the intersection from Valley View Road (major street) did not average at least 200 vehicles per hour over the same 8 hour period. There were a total of 980 southbound left turns, 712 northbound right turns, 842 westbound right turns and 374 westbound left turns during the 24 hour study.

Map: Valley View Rd. and Valley Ln.

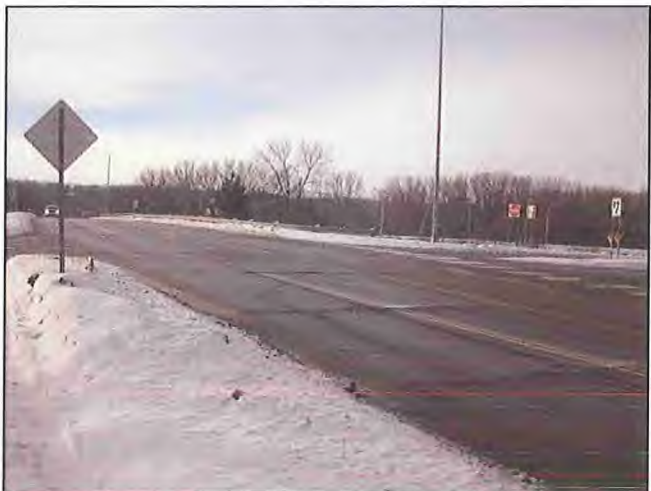
Currently there are stop signs located on westbound Valley View Road and the exit ramp from highway 62. The exit ramp has a right turn only lane and a left turn or through lane. Tracy Avenue has a left turn only lane northbound. The closest stop signs on Tracy Avenue are located at Olinger Boulevard to the north, and no close stop signs are located to the south.

Picture: Tracy Ave. and Valley View Rd. from north

After discussion the staff recommends including study of this intersection along with traffic analysis of Tracy / TH 62 associated with future Tracy Avenue reconstruction before making a recommendation.

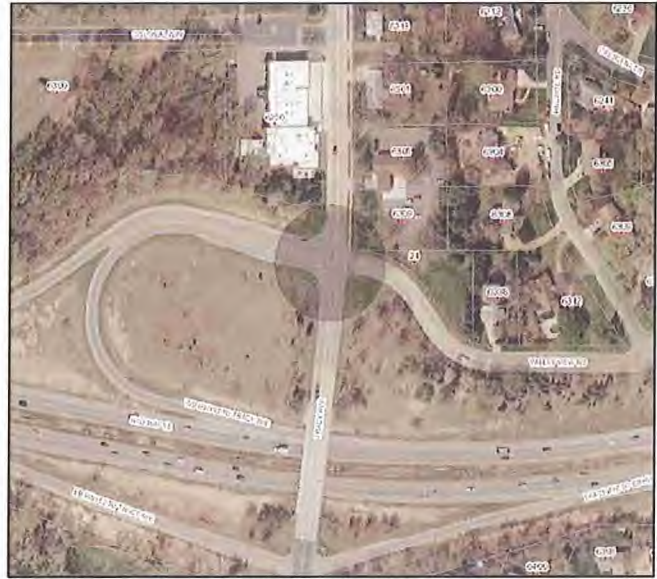
There most reported crashes in a 12-month period were four from 4/06 through 4/07, all of which were right angle collisions due to a failure to yield the right-of-way. As shown in the above table, during an 8 hour period greater than 300 vehicles per hour entered the major street approaches and greater than 200 vehicles per hour entered the minor street approaches. The average delay for vehicles crossing Tracy Avenue was calculated during the peak hour for the minor approaches, 17:30 to 18:30. The average delay was calculated to be 54 seconds. It should be noted this delay may have been greater, only vehicles which could be seen were counted, some vehicles may have been out of view of the camera. This delay is still greater than the minimum requirement of 30 seconds.

Map: Tracy Ave. and Valley View Rd.

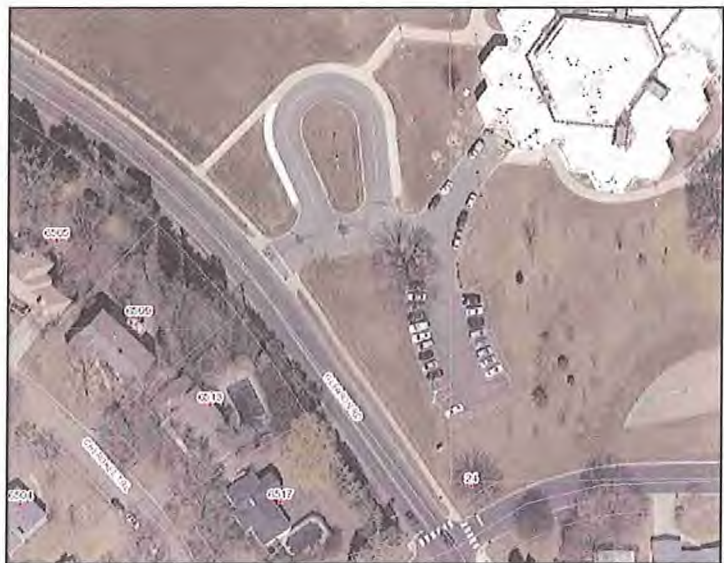
Currently there is a school speed limit of 20 mph on Gleason Road. There is No Parking on the east side of the road. There is No Parking on the east side of the road. There is an area for student drop off / pick up located on the school property as seen on the map. Gleason Road is 34 feet wide in this area.

Map: Gleason Rd. at Creek Valley School

After discussion the staff recommends coordination with the Parks Department and the School District for further study.

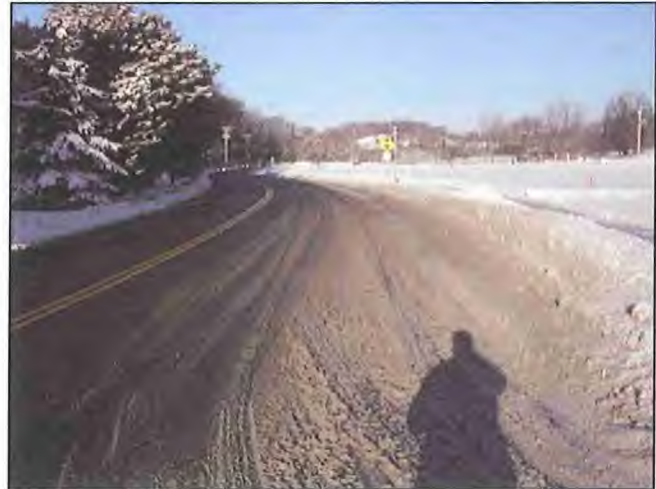
This request comes from a resident living in the area, they drive Gleason Road frequently. The requestor states; vehicles picking up children after school, at approximately 4 pm, are parking on and blocking Gleason Road, making it unsafe for travel. The requestor would like to see No Parking or No Pick Up on Gleason Road in front of the school.

Picture: Gleason Rd. from the south
